**OXFORD MAYOR AND COUNCIL
WORK SESSION
MONDAY, FEBRUARY 15, 2016 – 6:00 P.M.
CITY HALL
A G E N D A**

5. * **104 West Watson Street** – We acquired this house and lot as part of the Asbury Street Park. We have attached a copy of an inspection by a home inspector. After reviewing the report, we are recommending Council authorize us to tear down the house. We will get bids in time for the March Council meeting. The inspector's report is attached in three parts. The report is pretty long, but if you page through the pictures, you'll get the gist of it.

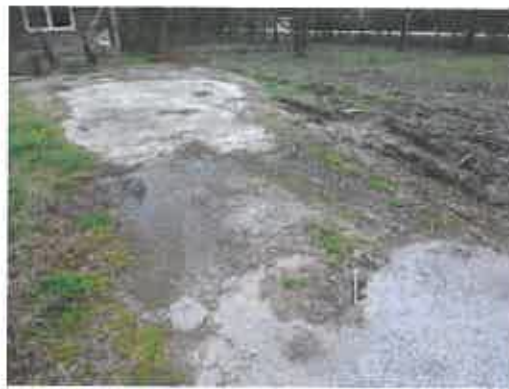
Photo 02.JPG

1C.24 Flatwork, concrete & asphalt: Settling, cracked at driveway (Photo 2). Recommendation: Repair or replace

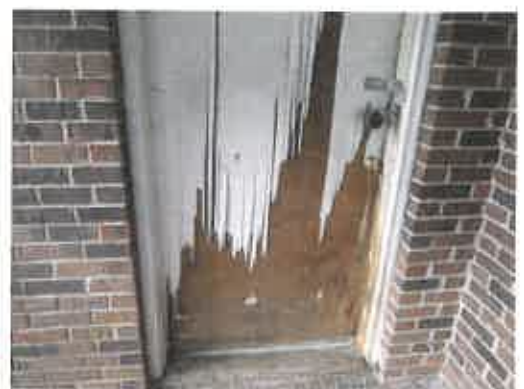
Photo 03.JPG

7C.02 Door attention recommended (delaminating/ deteriorating) at front exterior (Photo 3).
Recommendation: Replace

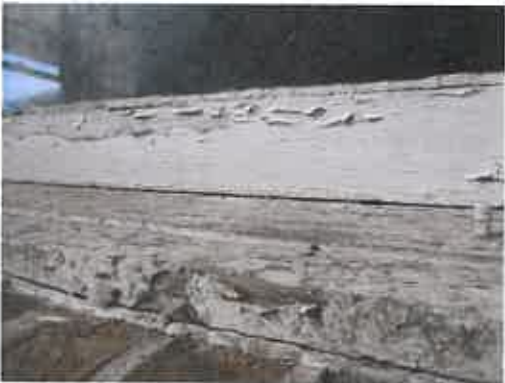
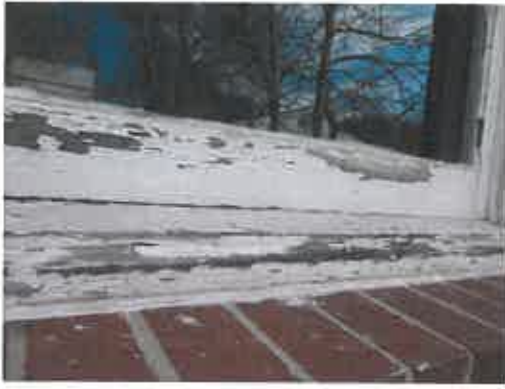
2P Paint deteriorating and peeling on all exterior wood finishes (Photos 4, 13 as examples).
Recommendation: Repair or replace

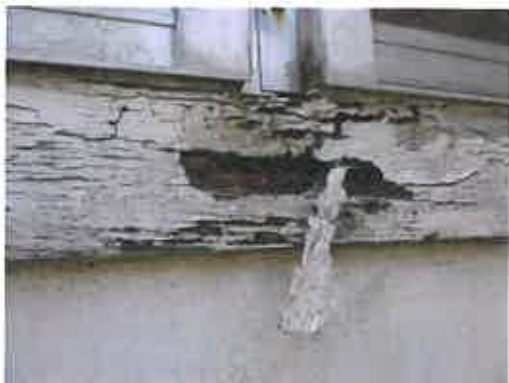
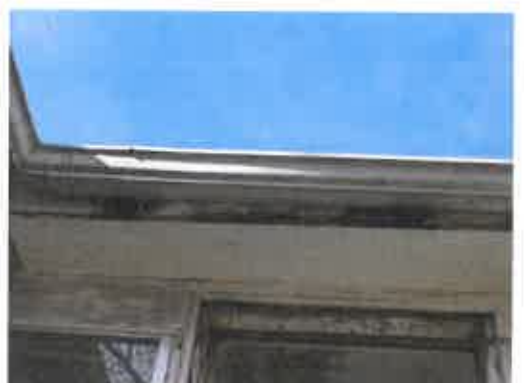
1C.06 Suspected water damage—Rot/decay found at; Trim boards, window sills and fascia boards at right exterior enclosed porch addition (Photos 5, 6 as examples), window sill at left front exterior (Photo 19) . Recommendation: Replace

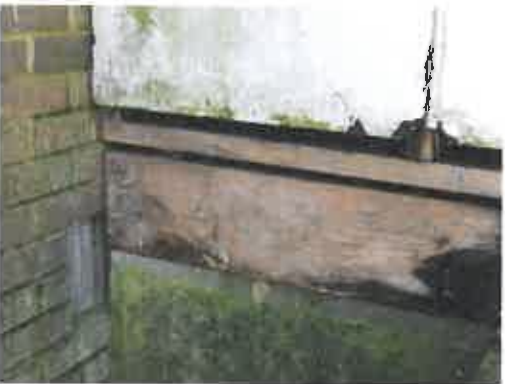
Photo_07.JPG

2C.23 Siding does not overlap structure, missing at lower right enclosed porch (Photo 7).
Recommendation: Replace

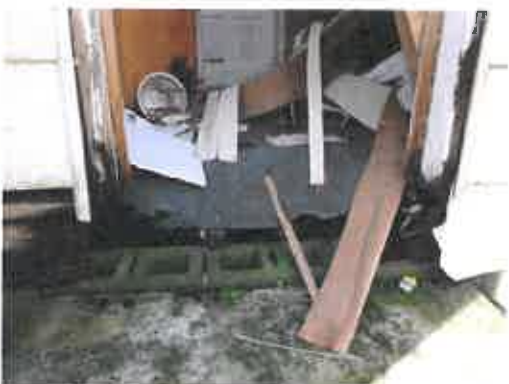
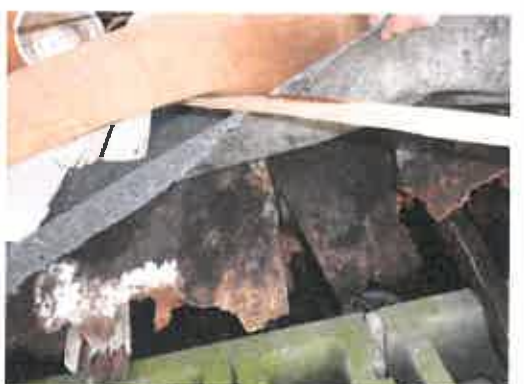
- 222 Evaluation by a specialist is recommended
- 223 [1C.06](#) **Wood rot found at floor structure and subflooring at right enclosed porch (Photos 8, 9, 59).**

- 224 **Recommendation: Replace as needed**
- 225 [1A.20](#) Structure comparative rating: apparently fairly good
- 226

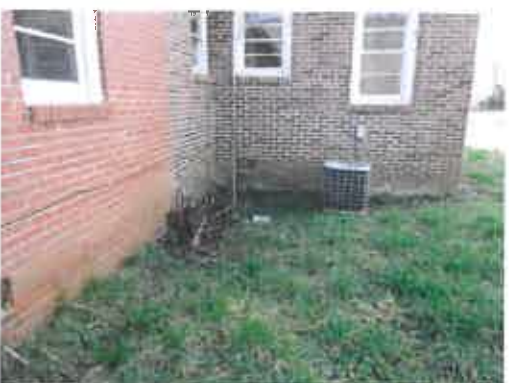
Photo 11.JPG

1D Grading/ drainage: Improve and maintain especially: at left side of house; where roof and surface water drain back toward the house (Photo 11) and at right side of house; where water is ponding (Photo 12). Repair is recommended

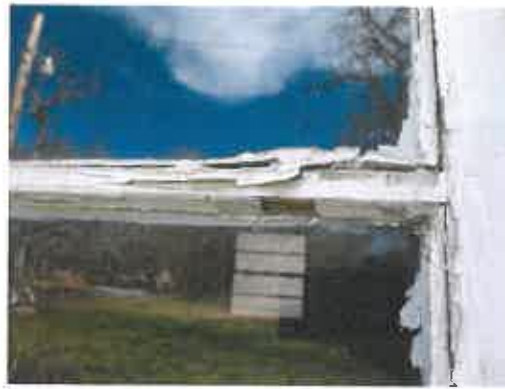
Photo 14.JPG

2C.01 Glazing compound (window "putty") deteriorating (cracked/ loose/ missing) at all windows (Photo 14 as example). Recommendation: Repair or replace

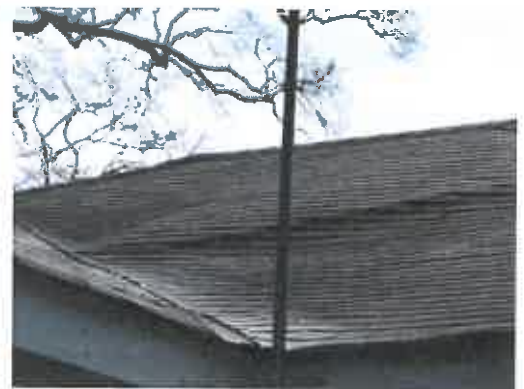
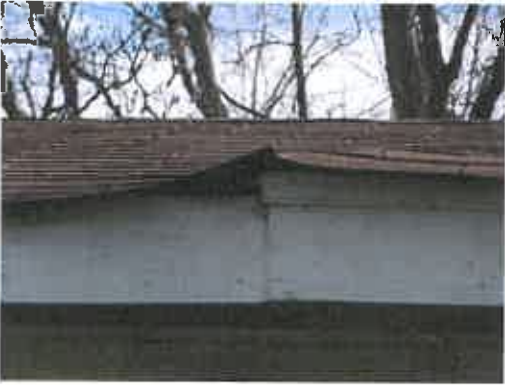
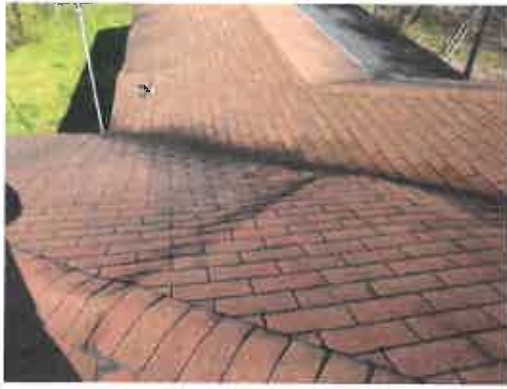
- 79 **3C.02 Shingles, asphalt: raised/ elevated/up (not resting flat) at intersections of roof additions to**
80 **existing roof structure (Photos 15, 16, 25 as examples). Two roof additions were**
81 **found onto original roof structure**

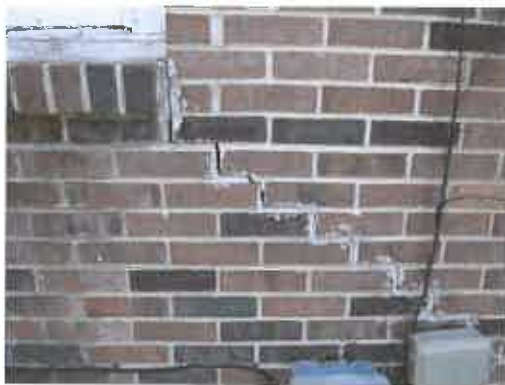
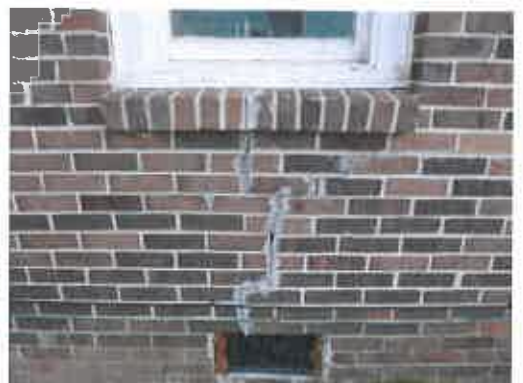
- 194 [7C.16](#) Floor/ subfloor decay/ delaminated in kitchen area under sink (Photo 58). Repair is
- 195 recommended
- 196 [1C.50](#) Instability/ settling indicators & phenomena: cracks in exterior masonry at left exterior (Photos

- 197 17, 30), some mortar joints appear to have been previously repaired (Photo 18).
- 198 Recommendation: Monitor for future functionality ([1B.00](#), [1B.13](#), [1C.21](#), [1C.28](#));

- 199 floor uneven/ unlevel ([1C.14](#)); . This is typical of a house of this age
- 200 [1C.10](#) Cracked joist at center of crawlspace (Photo 70, 71). Repair is recommended

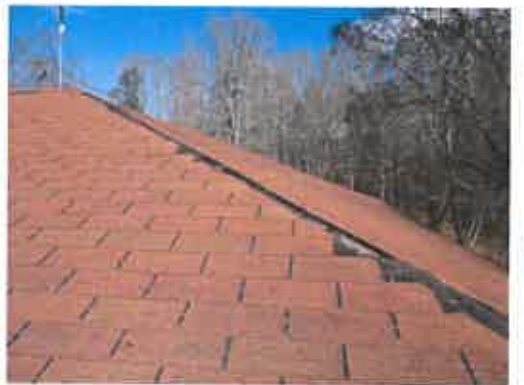
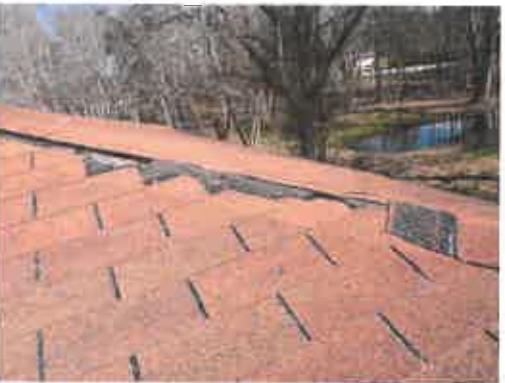
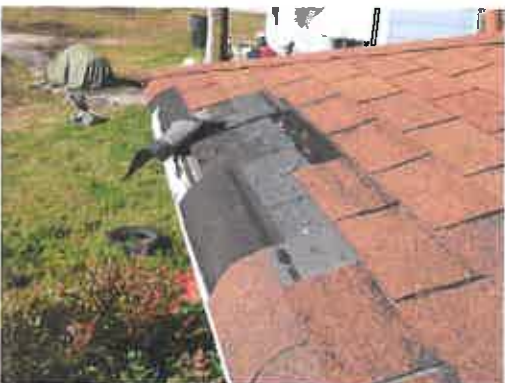
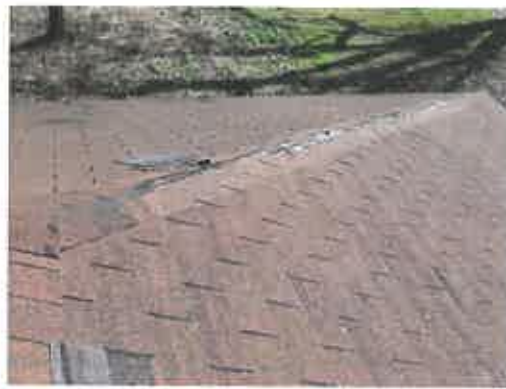
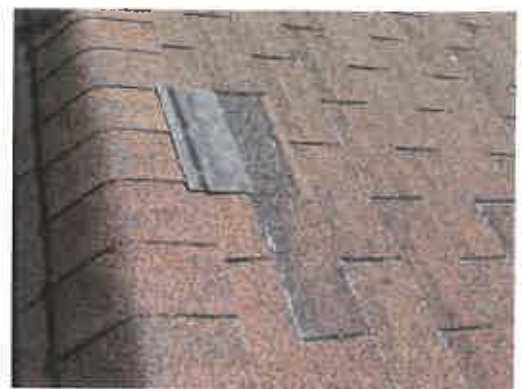
- 82 **3C.01 Shingles, broken/ cracked/ loose /missing along front eave edge, along front right hip rafter and**
83 **near ridge (Photos 20- 23, 26, 27). Recommendation: Repair or replace**

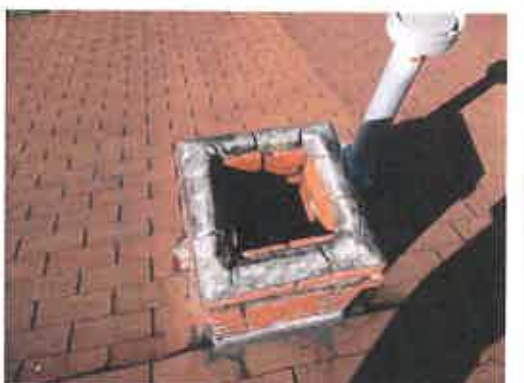
Photo 24.JPG

122 [6W](#) Flue liner; No liner installed in chimney- Do not use (Photo 24). Recommend chimney be
123 removed, which would allow greater flexibility in opening up the rooms.

6C.19 Chimney allows rain and pest entry into chimney flue (Photo 24). Recommend cap and screen be installed.

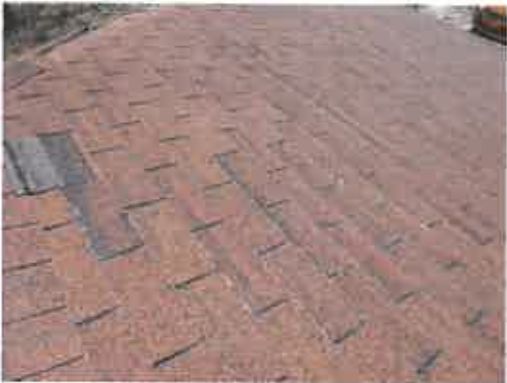
Photo_28.JPG

- 76 **3C.03 Shingles, asphalt: eroded/ pitted/ granules missing. (Photo 28). This item appears to be**
77 **approaching or at the end of its service life (15- 20 years old). Recommendation:**
78 **Replace**

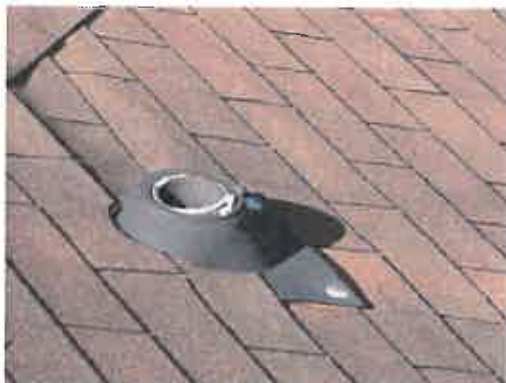
Photo_29.JPG

98 [4C.20](#) Attic: Plumbing vent pipe should extend through roof (Photo 29) Inadequate extension above
99 roof (12" min)

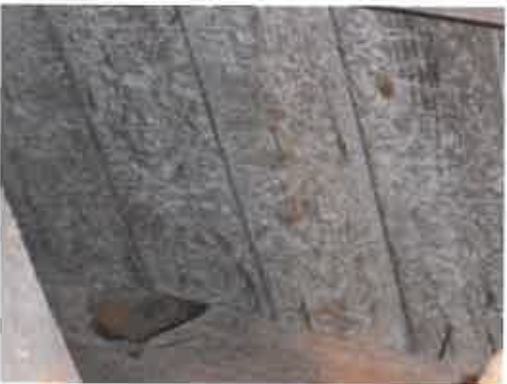
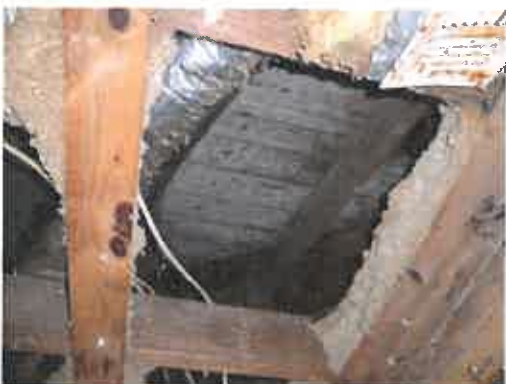
- 213 [1C.18](#) **Structure /foundation moisture indicators and phenomena: moisture visible; standing**
- 214 **water visible on floor; mold/mildew or fungus like material on roof sheathing/**

- 215 **framing above kitchen an master bathroom (Photos 31, 32 as examples) and**
- 216 **floor framing in crawlspace. Repair is recommended (see [1C.03](#), [9H](#), and [9D](#));**

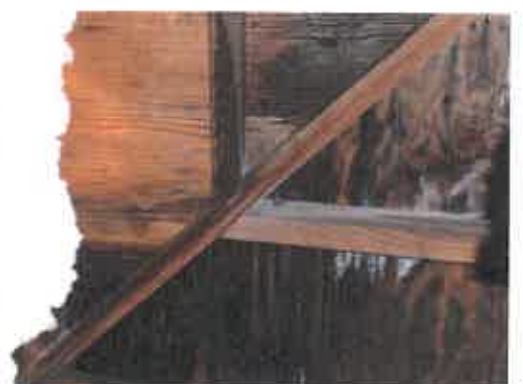
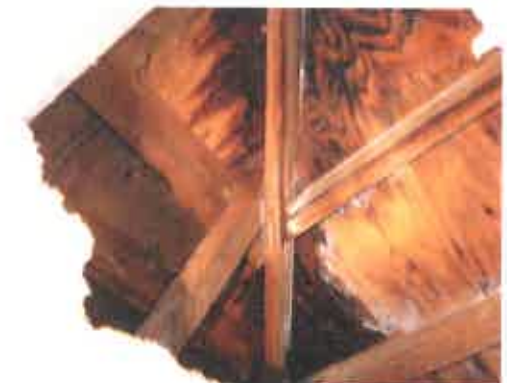
88 [3C.12](#) Water concern/ evidence, as indicated by wood that is discolored, soft, or rotting; at roof
89 framing/ sheathing along front right hip rafter (Photos 33, 34). Repair is
90 recommended

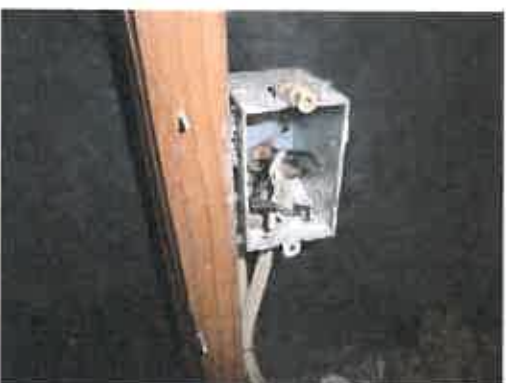
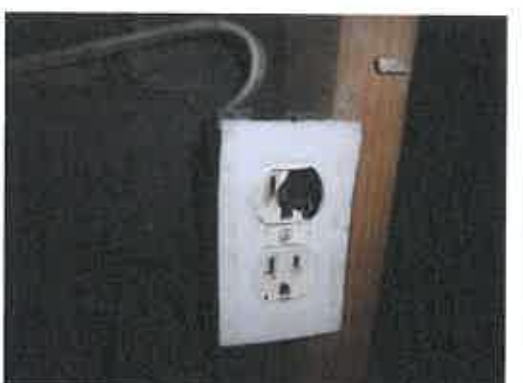
116 [5C.59](#) Receptacle broken / damaged/ missing in kitchen, dining room and right bedroom (Photo
117 35, 36 as example). Recommendation: Replace

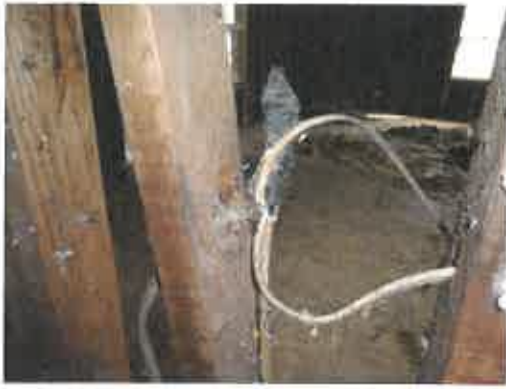
Photo 37.JPG

106 [5C.08](#) Box recommended to protect junction of wires found spliced behind the wall between
107 kitchen and bathroom (Photo 37). Repair is recommended

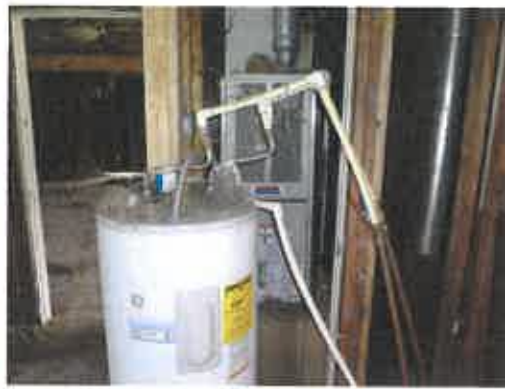
Photo 38.JPG

96 [4C.18](#) Support/ attachment inadequate for piping; pipes sagging at dislocated water heater (Photo 38).
97 Repair is recommended

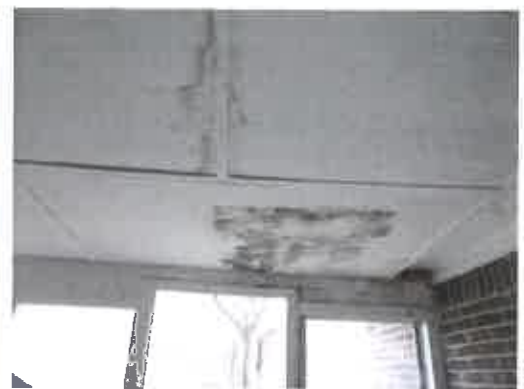
Photo 39.JPG

87 [3C.12](#) Stains found on ceiling of enclosed porch (Photo 39). Recommendation: Repair or replace

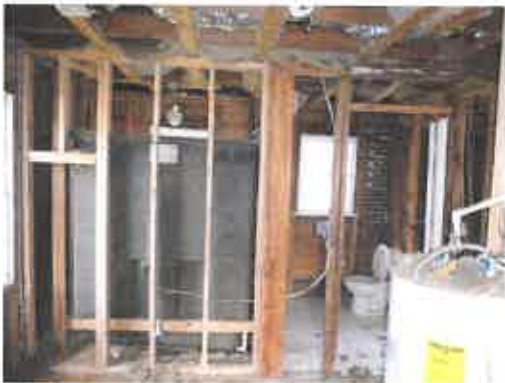
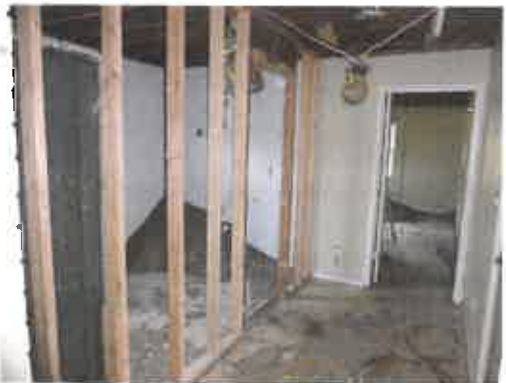
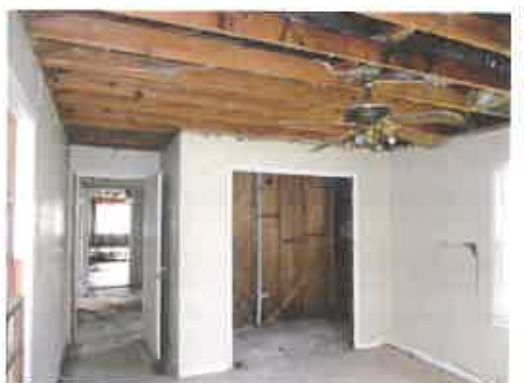
- 209 sagging (Photo 54). Repair is recommended
- 210 [3C.21](#) Partition walls at master bedroom, laundry room, master bathroom and rear addition bathroom /

- 211 bedroom are not load bearing, provide adequate support for roof load is provided
- 212 for (Photos 44, 46, 48). Evaluation by a specialist is recommended

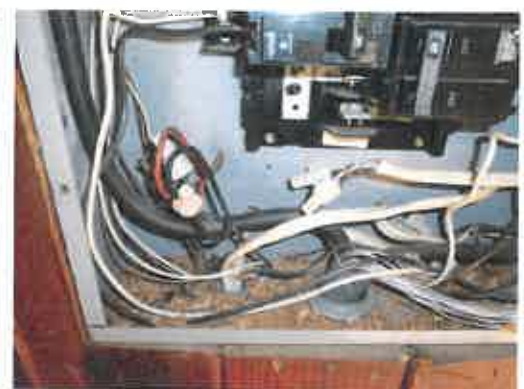
Photo 51.JPG

108 [5C.15](#) Cables not connected at bottom of panel box (Photo 51). Evaluation by a specialist is
109 recommended

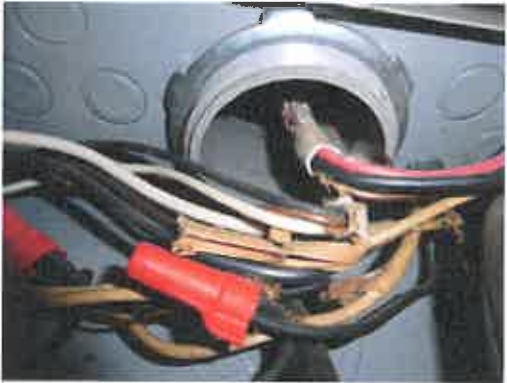
Photo_52.JPG

112 [5C.28](#) Connector should be used for all cables entering boxes; inadequate at top of panel box
113 (Photo 52). Repair is recommended

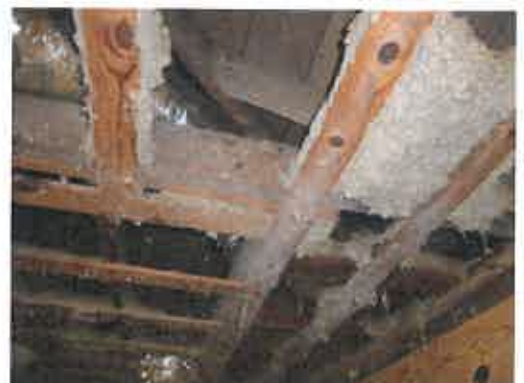
Photo_54.JPG

- [1C.59](#) Light/ substandard framing; ceiling rafters above kitchen have been spliced and appear to be sagging (Photo 54). Repair is recommended
- [3C.21](#) Partition walls at master bedroom, laundry room, master bathroom and rear addition bathroom / bedroom are not load bearing, provide adequate support for roof load is provided for (Photos 44, 46, 48). Evaluation by a specialist is recommended

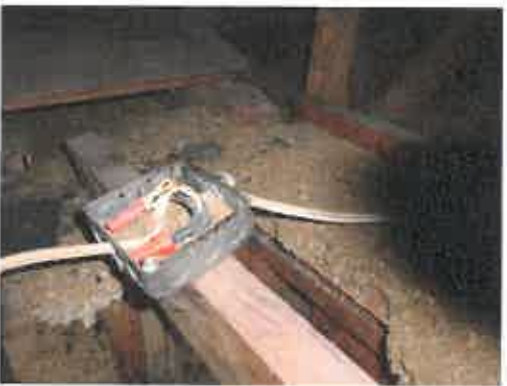
Photo_55.JPG

103 [5C.06](#) Box cover recommended for numerous open boxes found in attic and crawlspace (Photos
104 55, 65, 68). Repair is recommended

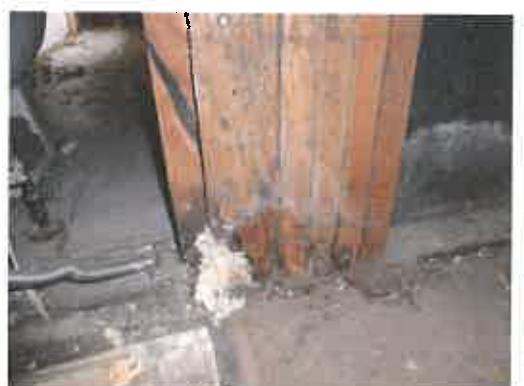
Photo_57.JPG

- 219 Exterior- Grading/ Drainage); vapor retarder recommended for crawl space (Photos
- 220 60, 64) ([1C.03](#) and [9D](#)).
- 221 [1C.06](#) Wood: insect and rot damage suspected at vertical studs on left side of kitchen (Photo 57).

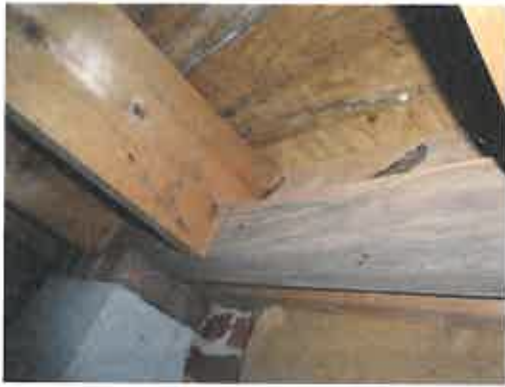
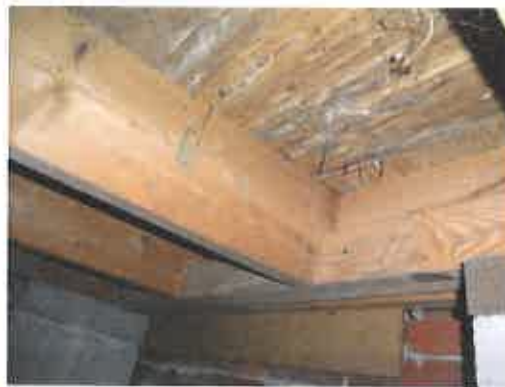
- 201 [1C.10](#) Cut/ notched exceeds 1/6th of joist width under rear addition (Photos 61, 62). Repair is
- 202 recommended
- 203 [1C.53](#) Vertical support (wall) between living room and front right bedroom is a load bearing wall, as is

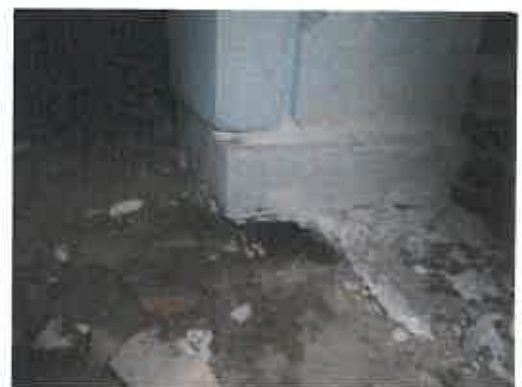
Photo 63.JPG

- 188 **Concerns: Structure**
- 189 [1C.56](#) Access in foundation crawl space was limited due to wall to wall mud on floor
- 190 [1C.47](#) Footing concern for column; inadequate footings found under columns at rear addition (Photo 63

- 191 as example). Repair is recommended
- 192 [1C.13](#) Floor soft/ springy/ "spongy" at center, between living room and kitchen (See also Structure-
- 193 Joist concerns)

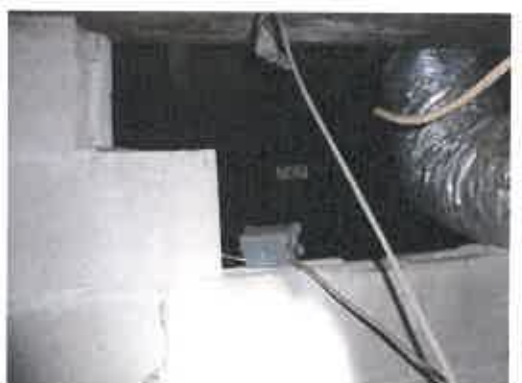
Photo_69.JPG

105 [5C.07](#) Box loose found in crawlspace under front right bedroom (Photo 69). Repair is recommended
