**MINUTES OF THE OXFORD MAYOR AND COUNCIL MEETING
WORK SESSION MEETING
MONDAY, FEBRUARY 15, 2016 – 6:00 P.M.
CITY HALL**

5. * **104 West Watson Street** – We acquired this house and lot as part of the Asbury Street Park. We have attached a copy of an inspection by a home inspector. After reviewing the report, we are recommending Council authorize us to tear down the house. We will get bids in time for the March Council meeting. The inspector's report is attached in three parts. The report is pretty long, but if you page through the pictures, you'll get the gist of it.

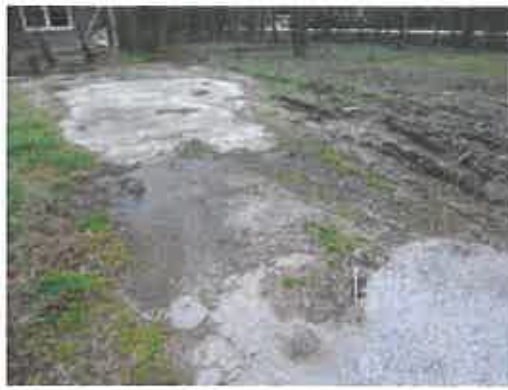
Photo 02.JPG

- 55 **1C.24** Flatwork, concrete & asphalt: Settling, cracked at driveway (Photo 2). **Recommendation: Repair**
56 **or replace**
- 57 **2P** Paint deteriorating and peeling on all exterior wood finishes (Photos 4, 13 as examples).
58 **Recommendation: Repair or replace**

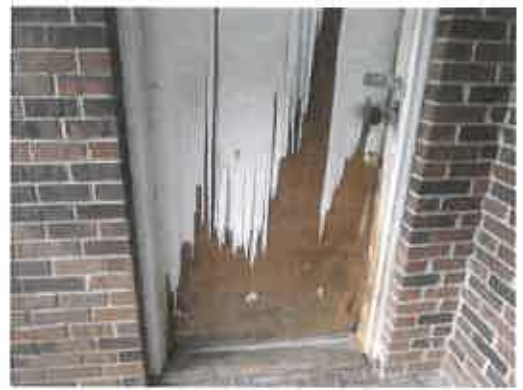
Photo 03.JPG

- 50 **Concerns: Exterior**
- 51 **6C.19** Chimney allows rain and pest entry into chimney flue (Photo 24). Recommend cap and screen be
52 installed.
- 53 **7C.02** Door attention recommended (delaminating/ deteriorating) at front exterior (Photo 3).
54 **Recommendation: Replace**

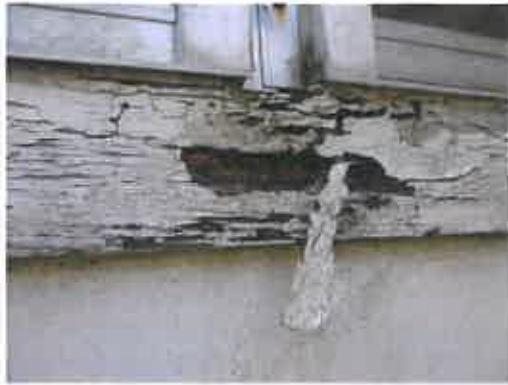
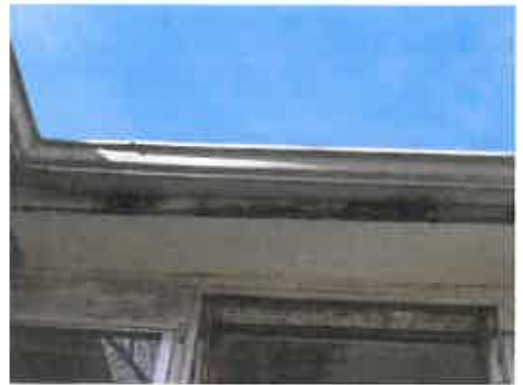
- 68 **1C.06** Suspected water damage—Rot/decay found at; Trim boards, window sills and fascia boards at
69 right exterior enclosed porch addition (Photos 5, 6 as examples), window sill at left
70 front exterior (Photo 19) . **Recommendation: Replace**

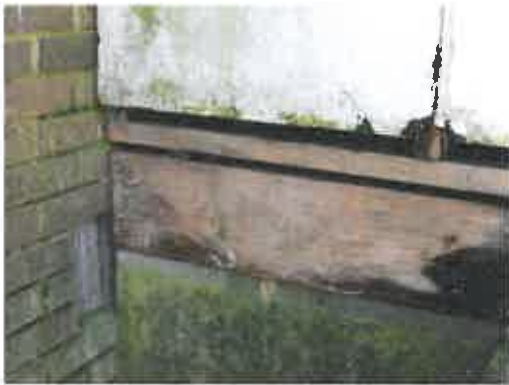
Photo_07.JPG

- 59 **2C.23** Siding does not overlap structure, missing at lower right enclosed porch (Photo 7).
60 **Recommendation: Replace**
- 61 **1D** Grading/ drainage: Improve and maintain especially: at left side of house; where roof and
62 surface water drain back toward the house (Photo 11) and at right side of house;
63 where water is ponding (Photo 12). Repair is recommended

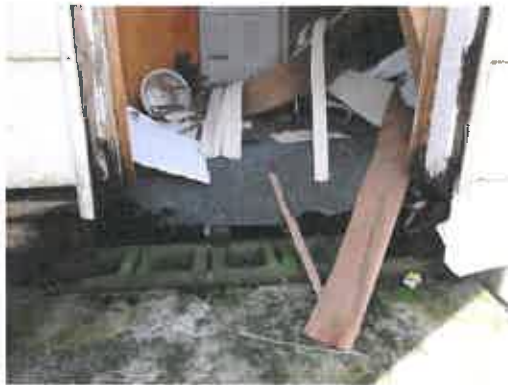
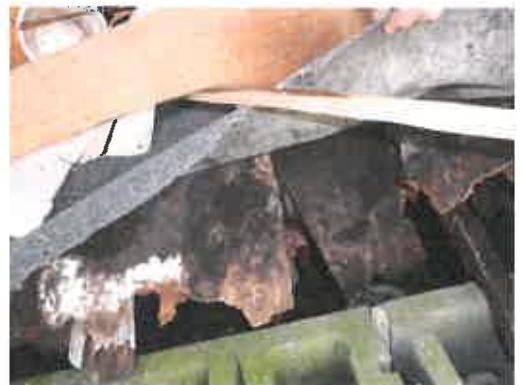
- 46 **1C.06** Wood rot found at floor structure and subflooring at right enclosed porch (Photos 8, 9, 59).
47 **Recommendation: Replace as needed**
- 48 **1A.20** Structure comparative rating: apparently fairly good
49

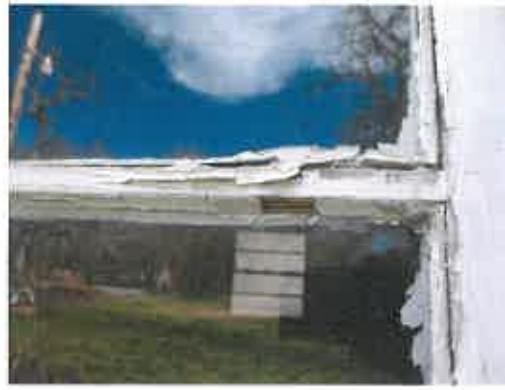
Photo 14.JPG

- 64 **2C.23** Water penetration through exterior at window at left front (Photo 53). **Repair is**
65 **recommended**
- 66 **2C.01** Glazing compound (window "putty") deteriorating (cracked/ loose/ missing) at all windows
67 (Photo 14 as example). **Recommendation: Repair or replace**

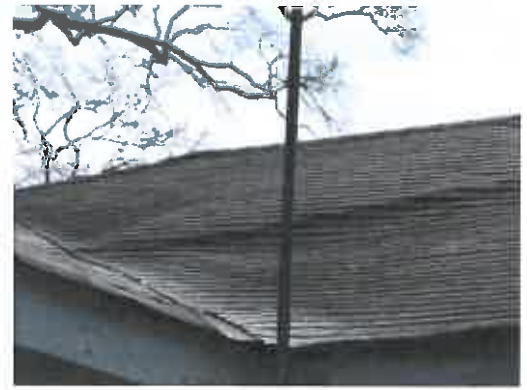
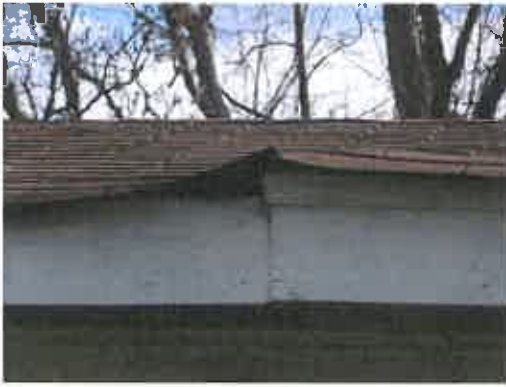
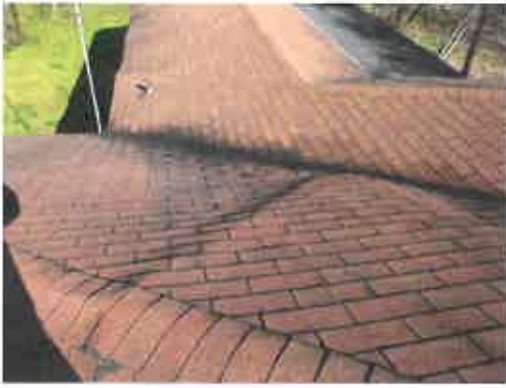
- 79 **3C.02** Shingles, asphalt: raised/ elevated/up (not resting flat) at intersections of roof additions to
80 existing roof structure (Photos 15, 16, 25 as examples). Two roof additions were
81 found onto original roof structure

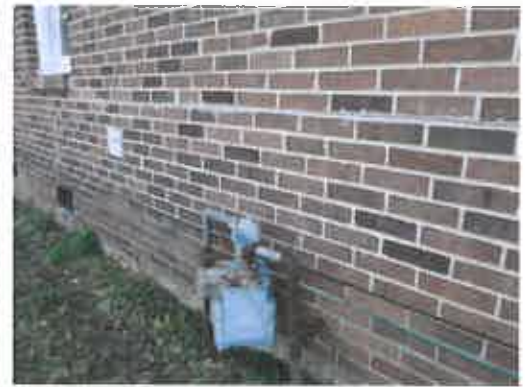
Photo_18.JPG

- 1C.50 Instability/ settling indicators & phenomena: cracks in exterior masonry at left exterior (Photos 17, 30), some mortar joints appear to have been previously repaired (Photo 18). Recommendation: Monitor for future functionality (1B.00, 1B.13, 1C.21, 1C.28); floor uneven/ unlevel (1C.14); . This is typical of a house of this age

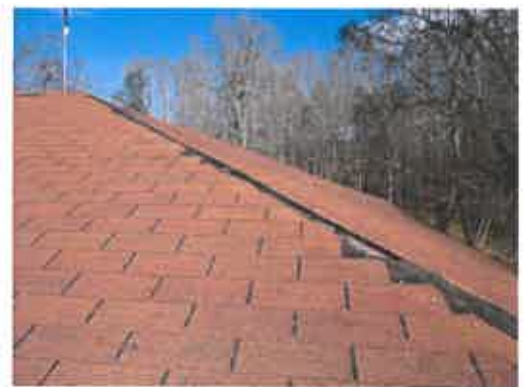
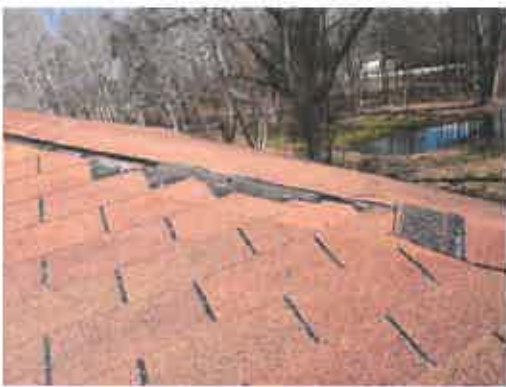
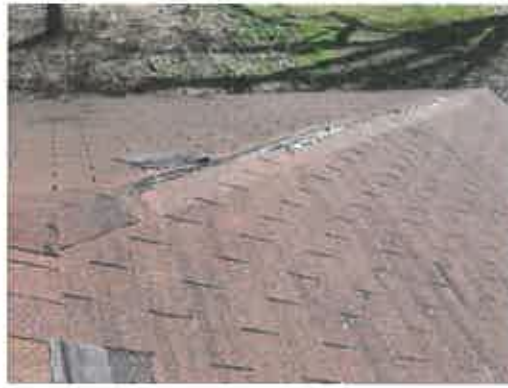
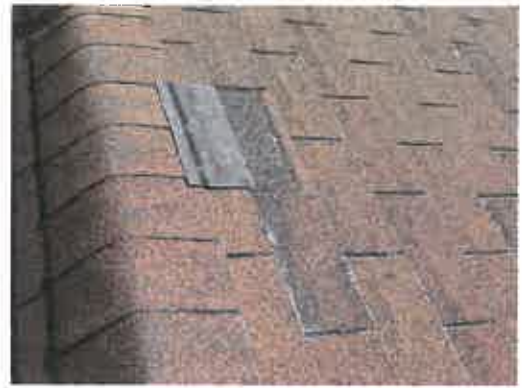
- 82 **3C.01** Shingles, broken/ cracked/ loose /missing along front eave edge, along front right hip rafter and
83 near ridge (Photos 20- 23, 26, 27). **Recommendation: Repair or replace**

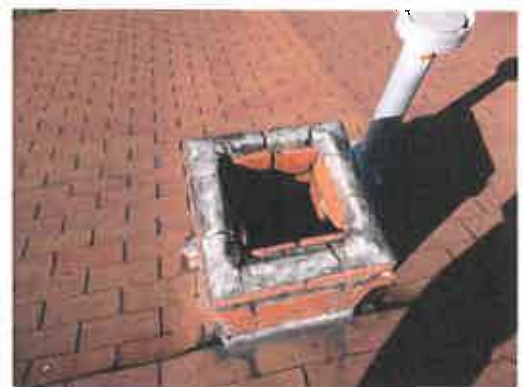
Photo 24.JPG

122 [6W](#) Flue liner; No liner installed in chimney- Do not use (Photo 24). Recommend chimney be
123 removed, which would allow greater flexibility in opening up the rooms.

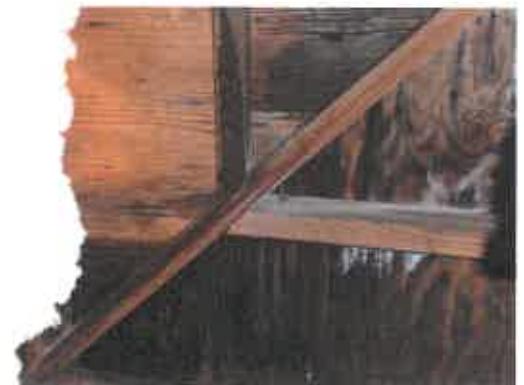
Photo_33.JPG

88 [3C.12](#) Water concern/ evidence, as indicated by wood that is discolored, soft, or rotting; at roof
89 framing/ sheathing along front right hip rafter (Photos 33, 34). Repair is
90 recommended

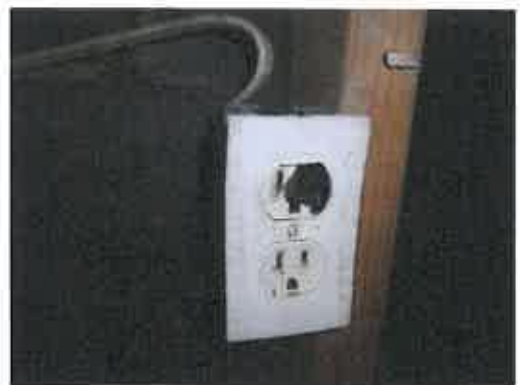
Photo 36.JPG

116 [5C.59](#) Receptacle broken / damaged/ missing in kitchen, dining room and right bedroom (Photo
117 35, 36 as example). Recommendation: Replace

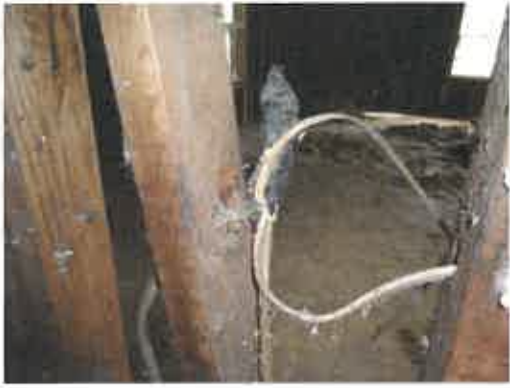
Photo 37.JPG

106 [5C.08](#) Box recommended to protect junction of wires found spliced behind the wall between
107 kitchen and bathroom (Photo 37). Repair is recommended

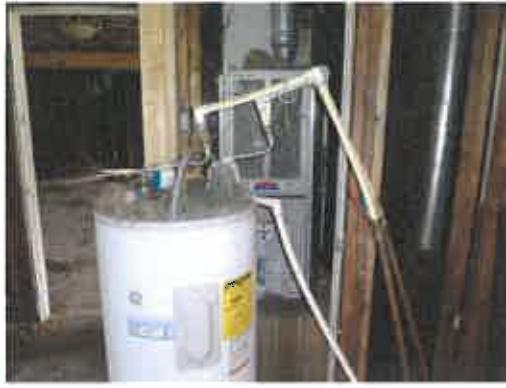
Photo 38.JPG

96 [4C.18](#) Support/ attachment inadequate for piping; pipes sagging at dislocated water heater (Photo 38).
97 Repair is recommended

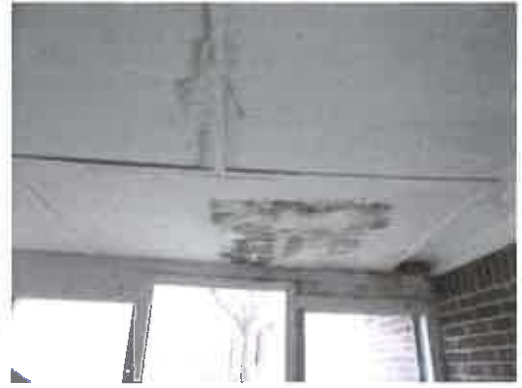
Photo 39.JPG

87 [3C.12](#) Stains found on ceiling of enclosed porch (Photo 39). Recommendation: Repair or replace

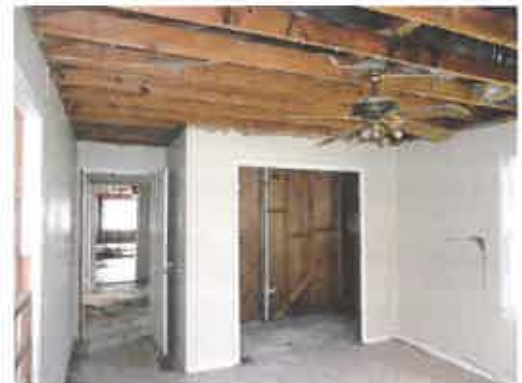
Photo 48.JPG

- 1C.59 Light/ substandard framing; ceiling rafters above kitchen have been spliced and appear to be sagging (Photo 54). Repair is recommended
- 3C.21 Partition walls at master bedroom, laundry room, master bathroom and rear addition bathroom / bedroom are not load bearing, provide adequate support for roof load is provided for (Photos 44, 46, 48). Evaluation by a specialist is recommended

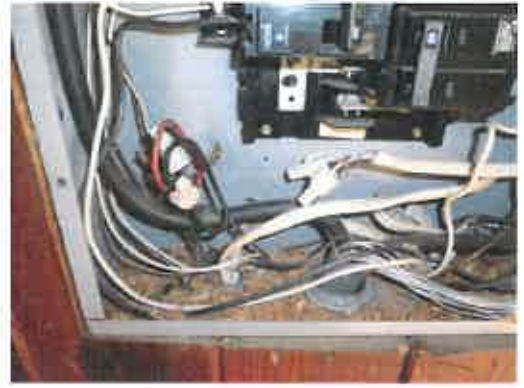
Photo 51.JPG

108 [5C.15](#) Cables not connected at bottom of panel box (Photo 51). Evaluation by a specialist is
109 recommended

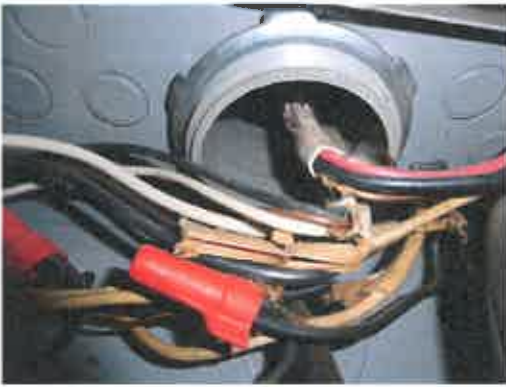
Photo_52.JPG

112 [5C.28](#) Connector should be used for all cables entering boxes; inadequate at top of panel box
113 (Photo 52). Repair is recommended

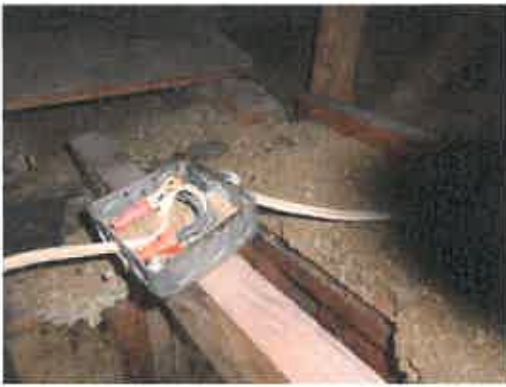
Photo_55.JPG

103 [5C.06](#) Box cover recommended for numerous open boxes found in attic and crawlspace (Photos
104 55, 65, 68). Repair is recommended

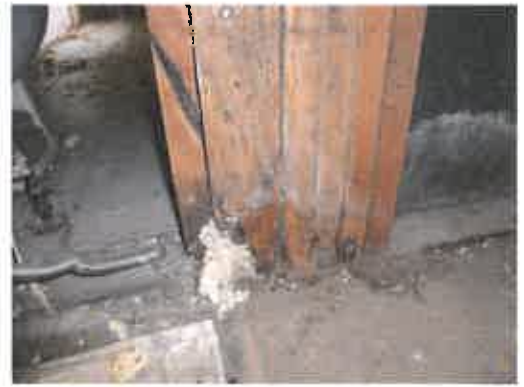
Photo_57.JPG

- 1C.06 Wood: insect and rot damage suspected at vertical studs on left side of kitchen (Photo 57). Evaluation by a specialist is recommended

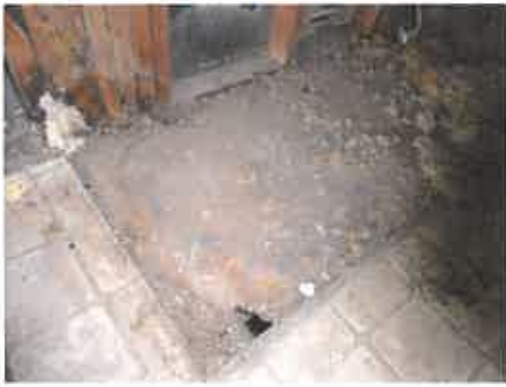
Photo 58.JPG

- 1C.13 Floor soft/ springy/ "spongy" at center, between living room and kitchen (See also Structure-Joist concerns)
- 7C.16 Floor/ subfloor decay/ delaminated in kitchen area under sink (Photo 58). Repair is recommended

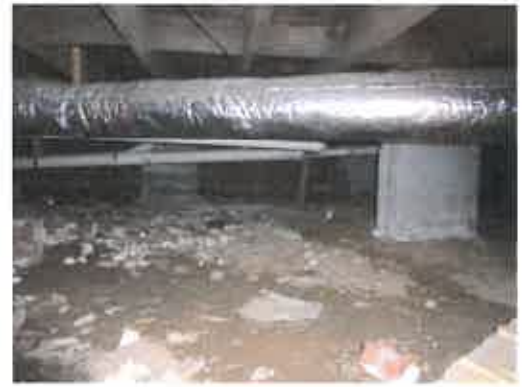
Photo 60.JPG

- 1C.18 Structure /foundation moisture indicators and phenomena: moisture visible; standing water visible on floor; mold/mildew or fungus like material on roof sheathing/ framing above kitchen an master bathroom (Photos 31, 32 as examples) and floor framing in crawlspace. Repair is recommended (see 1C.03, 9H, and 9D); stains visible on foundation walls (Photos 66, 67); soil wet to touch; in crawl space (see 1C.03); (moisture perhaps due to water penetration); (See Roof- Gutters, Exterior- Grading/ Drainage); vapor retarder recommended for crawl space (Photos 60, 64) (1C.03 and 9D).

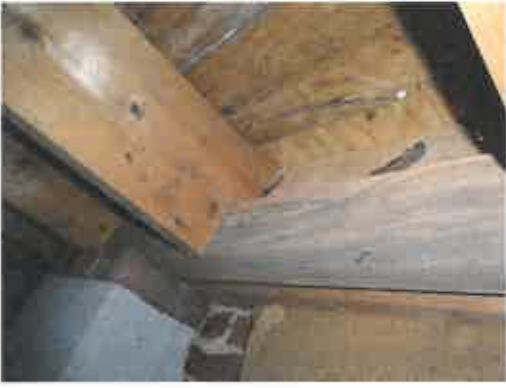
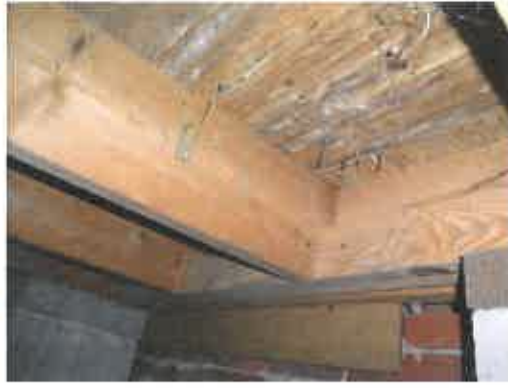
- 1C.10 Cracked joist at center of crawlspace (Photo 70, 71). Repair is recommended
- 1C.10 Cut/ notched exceeds 1/6th of joist width under rear addition (Photos 61, 62). Repair is recommended

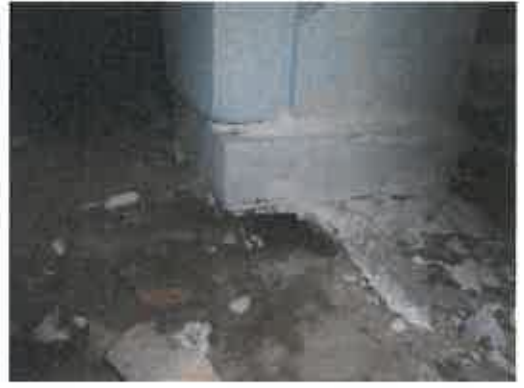
Photo 63.JPG

- 1C.56 Access in foundation crawl space was limited due to wall to wall mud on floor
- 1C.47 Footing concern for column; inadequate footings found under columns at rear addition (Photo 63 as example). Repair is recommended

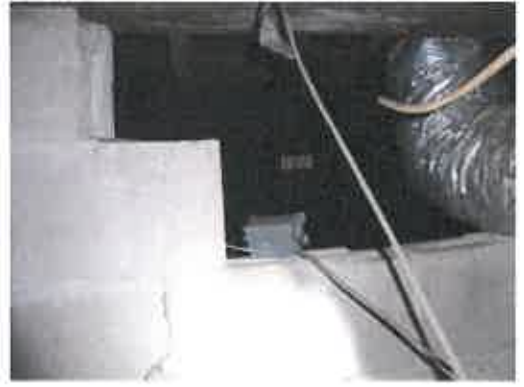
Photo_69.JPG

105 [5C.07](#) Box loose found in crawlspace under front right bedroom (Photo 69). Repair is recommended
