**OXFORD MAYOR AND COUNCIL
WORK SESSION
MONDAY, FEBRUARY 15, 2016 – 6:00 P.M.
CITY HALL
A G E N D A**

5. * **104 West Watson Street** – We acquired this house and lot as part of the Asbury Street Park. We have attached a copy of an inspection by a home inspector. After reviewing the report, we are recommending Council authorize us to tear down the house. We will get bids in time for the March Council meeting. The inspector's report is attached in three parts. The report is pretty long, but if you page through the pictures, you'll get the gist of it.

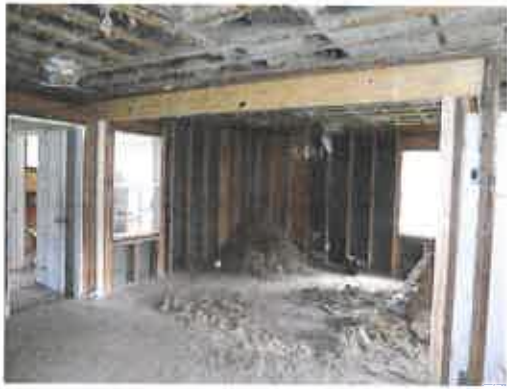
Photo 49.JPG

- [1C.44](#) Vertical support has been removed to "open up" a room between kitchen and dining room, this is a load bearing wall and a header has been installed (Photo 49). Appeared adequate and stable

- 206 a load bearing wall and a header has been installed (Photo 49). Appeared adequate
- 207 and stable
- 208 [1C.59](#) Light/ substandard framing; ceiling rafters above kitchen have been spliced and appear to be

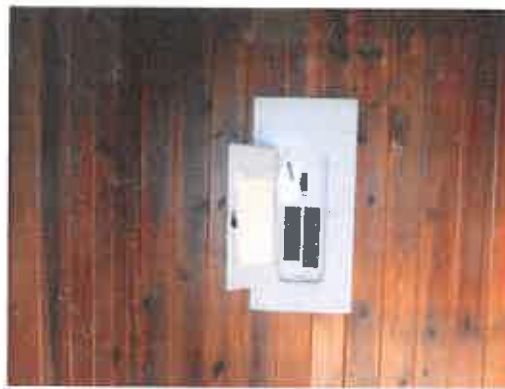
Photo 50.JPG

118 [5A.40](#) Electrical comparative rating: apparently fairly good? ([5A.22](#) electricity off); Electrical panel
119 box has been updated, 150 amp box installed in master bedroom (Photo 50).

- 312 **5C.28** Connector should be used for all cables entering boxes; inadequate at top of panel box
313 (Photo 52). Repair is recommended
314 **5C.69** Smoke detectors/ alarms attention: Recommend replacing “Ionization” type alarms with
315 “Photo- Electric” type for additional safety.
316 **5C.59** Receptacle broken / damaged/ missing in kitchen, dining room and right bedroom (Photo
317 35, 36 as example). Recommendation: Replace
318 **5A.40** Electrical comparative rating: apparently fairly good? (**5A.22** electricity off); Electrical panel
319 box has been updated, 150 amp box installed in master bedroom (Photo 50).

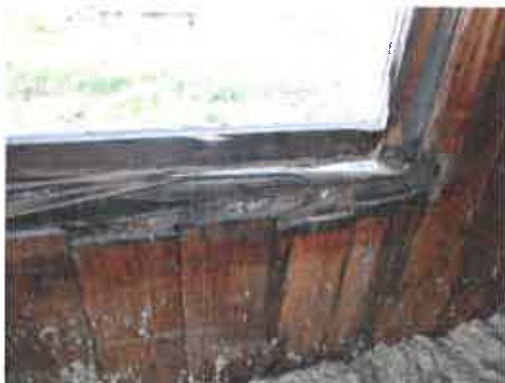
Photo_53.JPG

- 64 **2C.23 Water penetration through exterior at window at left front (Photo 53). Repair is**
65 **recommended**
- 66 **2C.01 Glazing compound (window "putty") deteriorating (cracked/ loose/ missing) at all windows**
67 **(Photo 14 as example). Recommendation: Repair or replace**

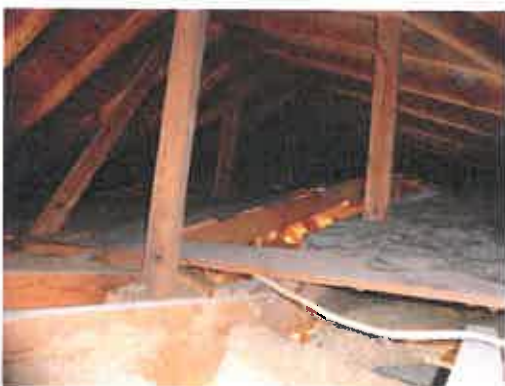
Photo_56.JPG

- 270 [1G.15](#) Roof structure: There appears to be two additions onto the original roof structure, one to the right
271 and another one to the rear later on. (Photo 56 as example at living room area). See
272 also Roof- Shingles concerns
273 [3C.12](#) Stains found on ceiling of enclosed porch (Photo 39). Recommendation: Repair or replace
274 [3C.12](#) Water concern/ evidence, as indicated by wood that is discolored, soft, or rotting; at roof
275 framing/ sheathing along front right hip rafter (Photos 33, 34). Repair is
276 recommended
277 [3A.20](#) Roof (not roof structure) comparative rating: apparently poor
278 [3A.20](#) Roof replacement needed now? Probably.

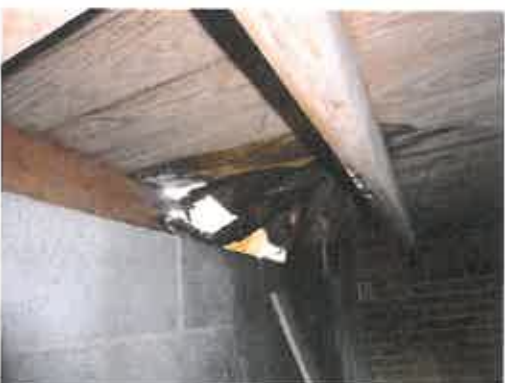
Photo 59.JPG

- 46 **1C.06 Wood rot found at floor structure and subflooring at right enclosed porch (Photos 8, 9, 59).**
47 **Recommendation: Replace as needed**
- 48 **1A.20 Structure comparative rating: apparently fairly good**
49

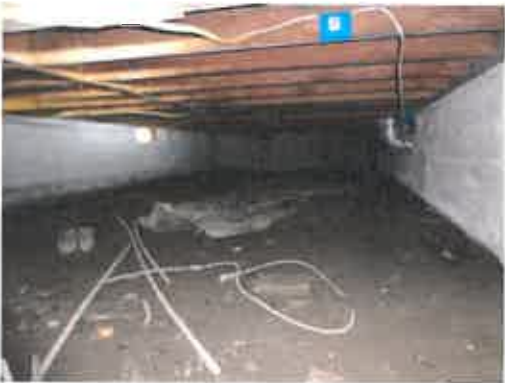
Photo_64.JPG

- [1C.18](#) **Structure /foundation moisture indicators and phenomena: moisture visible; standing water visible on floor; mold/mildew or fungus like material on roof sheathing/ framing above kitchen an master bathroom (Photos 31, 32 as examples) and floor framing in crawlspace. Repair is recommended (see [1C.03](#), [9H](#), and [9D](#)); stains visible on foundation walls (Photos 66, 67); soil wet to touch; in crawl space (see [1C.03](#)); (moisture perhaps due to water penetration); (See Roof- Gutters, Exterior- Grading/ Drainage); vapor retarder recommended for crawl space (Photos 60, 64) ([1C.03](#) and [9D](#)).**
