**MINUTES OF THE OXFORD MAYOR AND COUNCIL MEETING
WORK SESSION MEETING
MONDAY, FEBRUARY 15, 2016 – 6:00 P.M.
CITY HALL**

5. * **104 West Watson Street** – We acquired this house and lot as part of the Asbury Street Park. We have attached a copy of an inspection by a home inspector. After reviewing the report, we are recommending Council authorize us to tear down the house. We will get bids in time for the March Council meeting. The inspector's report is attached in three parts. The report is pretty long, but if you page through the pictures, you'll get the gist of it.

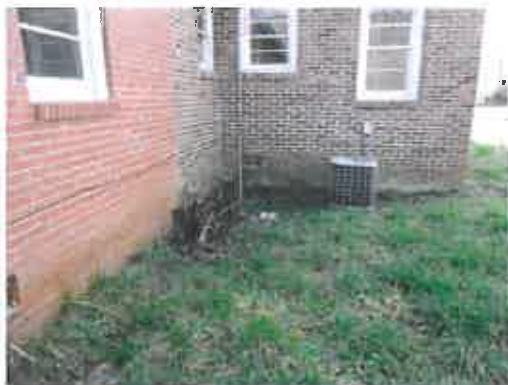
Photo 11.JPG

- 59 **2C.23** Siding does not overlap structure, missing at lower right enclosed porch (Photo 7).
60 **Recommendation: Replace**
- 61 **1D** Grading/ drainage: Improve and maintain especially: at left side of house; where roof and
62 surface water drain back toward the house (Photo 11) and at right side of house;
63 where water is ponding (Photo 12). Repair is recommended

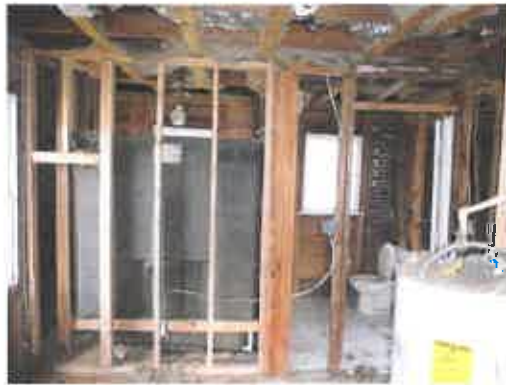
Photo_44.JPG

201 [1C.10](#) Cut/ notched exceeds 1/6th of joist width under rear addition (Photos 61, 62). Repair is
202 recommended
203 [1C.53](#) Vertical support (wall) between living room and front right bedroom is a load bearing wall, as is
204 the rear wall behind the kitchen and dining room.
205 [1C.44](#) Vertical support has been removed to "open up" a room between kitchen and dining room, this is
206 a load bearing wall and a header has been installed (Photo 49). Appeared adequate
207 and stable
208 [1C.59](#) Light/ substandard framing; ceiling rafters above kitchen have been spliced and appear to be
209 sagging (Photo 54). Repair is recommended
210 [3C.21](#) Partition walls at master bedroom, laundry room, master bathroom and rear addition bathroom /
211 bedroom are not load bearing, provide adequate support for roof load is provided
212 for (Photos 44, 46, 48). Evaluation by a specialist is recommended

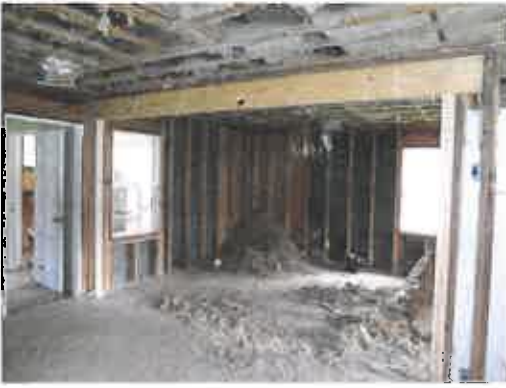
Photo 49.JPG

- 1C.44 Vertical support has been removed to "open up" a room between kitchen and dining room, this is a load bearing wall and a header has been installed (Photo 49). Appeared adequate and stable

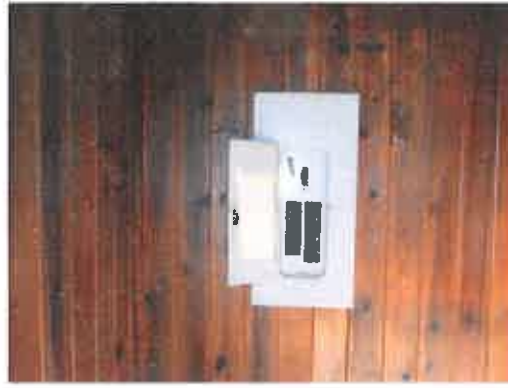
Photo 50.JPG

118 [5A.40](#) Electrical comparative rating: apparently fairly good? ([5A.22](#) electricity off); Electrical panel
119 box has been updated, 150 amp box installed in master bedroom (Photo 50).
